St. Catherine Parish Church

Zejtun

Restoration Method Statement

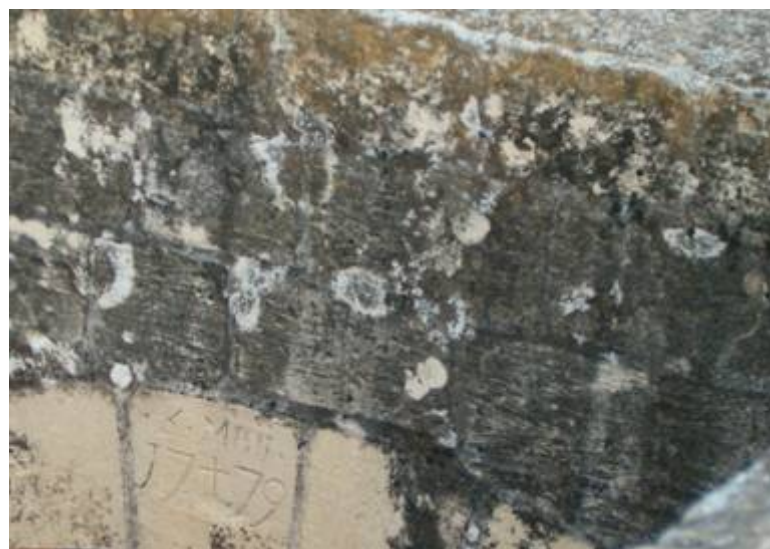
- 4.8 **Biological growth** is not harmful to the stone surface and this is mostly found on areas which are not exposed to direct sunlight. However areas dominated by such growth are considered to be aesthetically unacceptable due to the dark appearance of the stone.

- iv. **Superficial deposits, staining and biological growth** – Stone surface to be cleaned by nylon brushes after moistening the stone with distilled water and paper pulp when necessary.

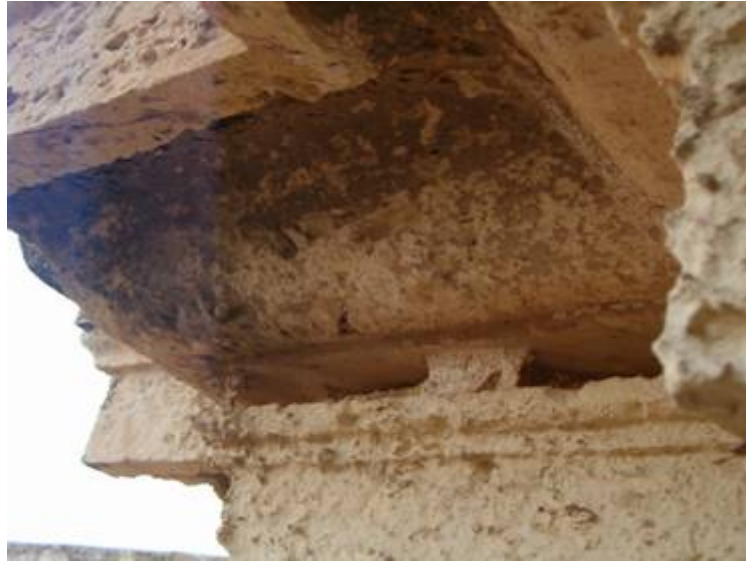
- 4.9 **Black crust** is found under the cornices on areas which are not visible on elevation. Black crust is formed up by the setting of

pollutants on the stone surface and later on reacts with the stone and erodes the stone.

- v. **Black crust** – will be cleaned after moistening by paper pulp and distilled water using nylon brushes and surgical blades. In certain areas where and when necessary, micro blasting at controlled pressure using glass bubbles will be used. A lime wash (*velatura*) will be given after cleaning or toning down of black crust in order to obtain a consistent appearance.
